Manhole Inspection Summary

Manhole # S35WW_020MH

Location Address: **3000 ABELL AVE**

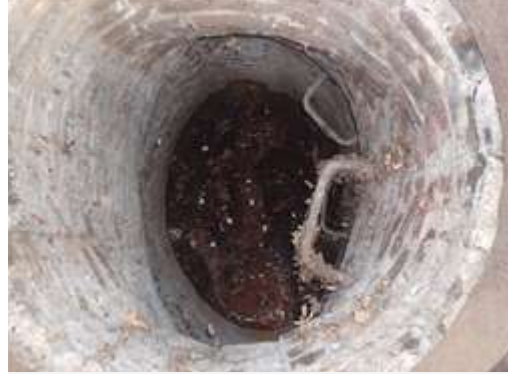
Top View

Channel debris.

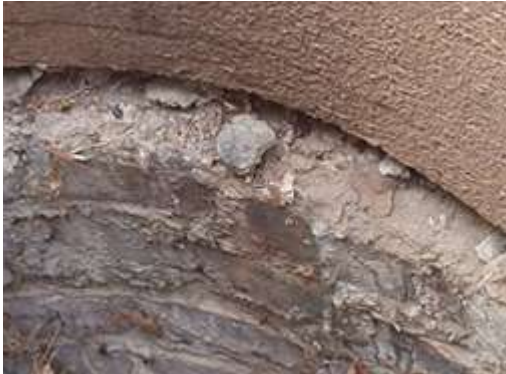
Defect

Frame leaks. Adjustment deterioration, root intrusion and infiltration.

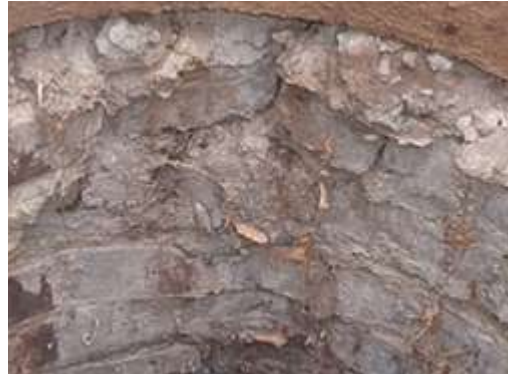
Defect

Frame leaks. Adjustment and Corbel deterioration, root intrusion and infiltration.

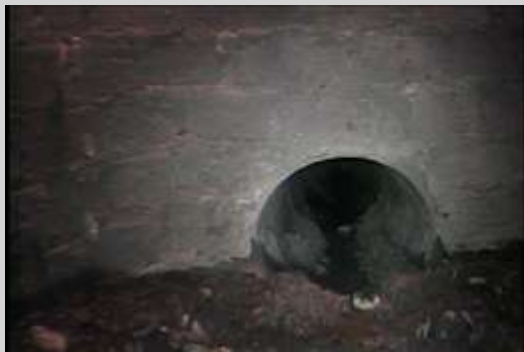
8 in. Circular Gravity Sewer
Pipe Out @ 12 O'Clock

Deposits: ☐ None ☒ **Mud** ☐ Sludge ☒ **Debris** ☐ Grease

Silt Depth: **2** (in.) Deposits Extent: **Light**
